Case Report

Metallosis caused by post-traumatic damage to polyethylene liner and acetabular cup after primary metal-on-polyethylene THA.

Department of Orthopaedics, ESI PGIMSR
New Delhi - 110015

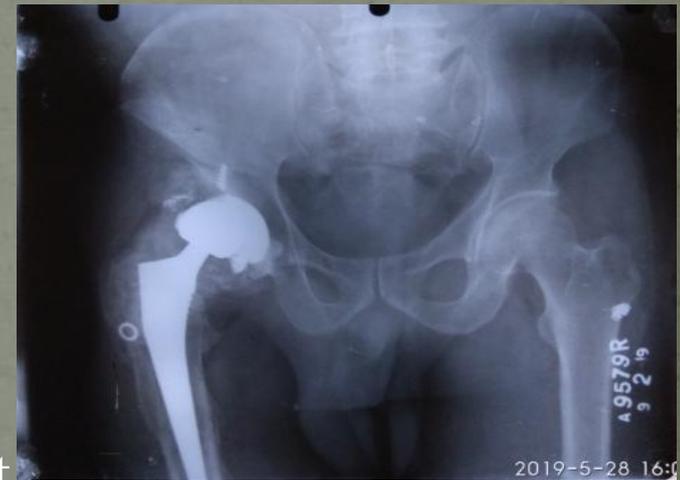
- 70 year M, non diabetic, with metal on polyethylene uncemented THR done 6 yrs ago for sec AVN,
- presented with pain and instability of hip with h/o fall 6 mths back
- Hip movements – reduced, painful.
- well healed scar
- TLC,DLC, ESR & CRP -NAD
- Pelvic Xray- superolateral breach of acetabular cup, metallic fragments arnd the neck and opacity around left hip joint.
- CT Scan-Linear failure, acetabular cup breakage & radio-opacity around hip joint.

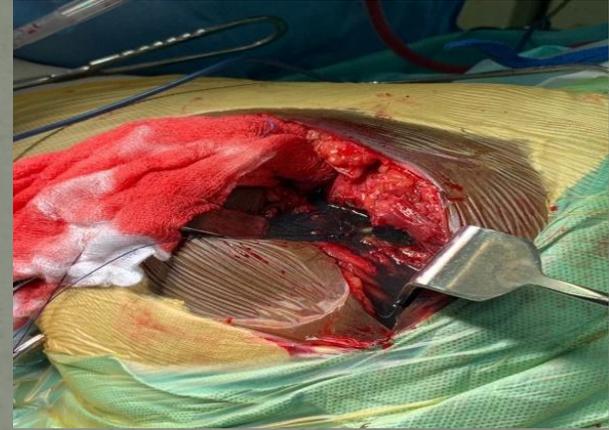
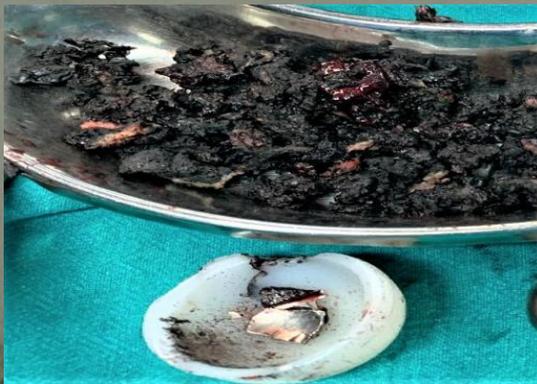
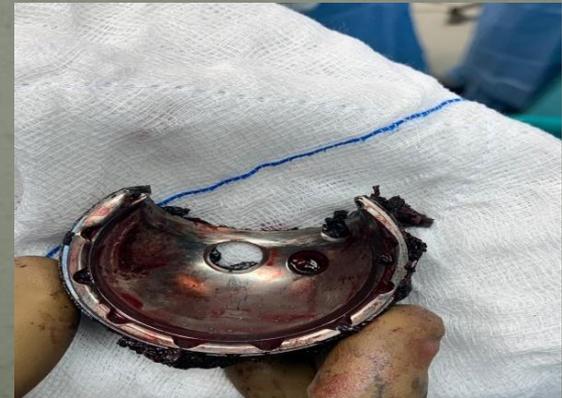
- MRI - not done as metal artifact suppression technique not available in our setup.
- scheduled for revision surgery.
- Intraop findings- pseudocapsule with dark metal debris scattered in the soft tissue surrounded by a dark, black fluid and Partially worn out poly liner and acetabular shell.
- Periprosthetic soft tissue which was excised.

- The cup was revised using a pinnacle revision cup (58mm, titanium alloy) fixed with multiple screws (4 peripheral + 3 inner screws). Ceramic liner(52mm) with ceramic femoral head (34mm) was used.

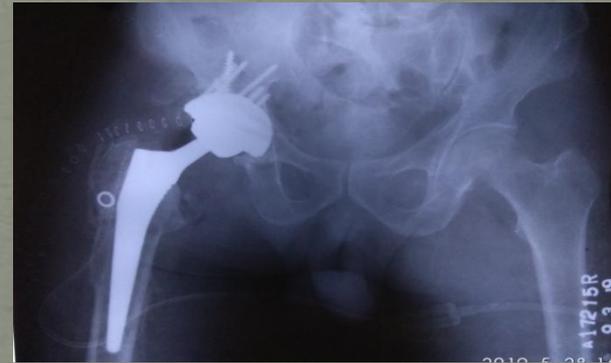
- Postoperative radiograph showing acetabular revision.

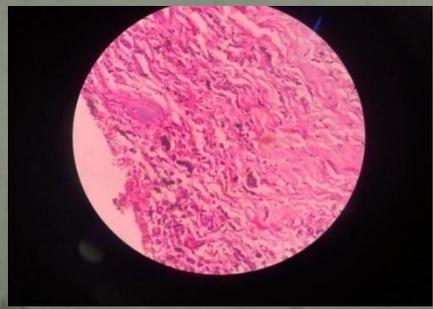
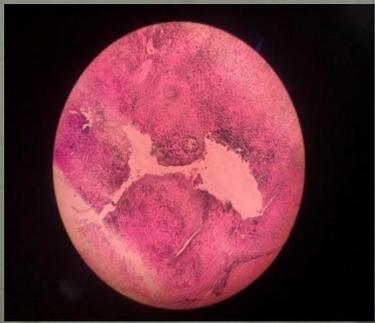
- Biopsy - dense fibro-cartilaginous tissue with interspersed brown-black debris with giant cell reaction indicating metallosis.
